# COMBINED FIRE AND HEALTH & SAFETY RISK ASSESSMENT.

| Address of premises: | 16-32 Woolston Place;<br>Sherfield on Loddon;<br>Hook;<br>RG27 0FH |
| Date of fire risk assessment: | 11 <sup>th</sup> July 2024 |

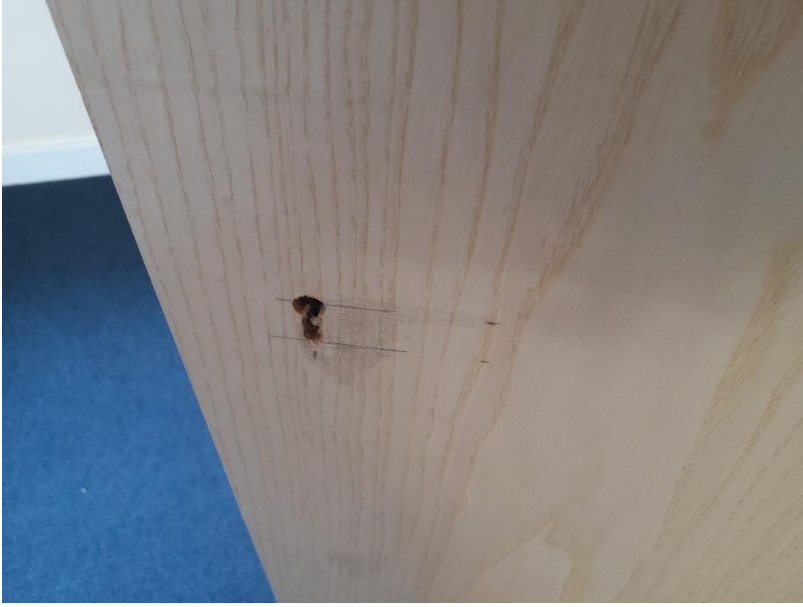
| 04 | <p>It was noted during this fire risk assessment that all riser doors and the electrical intake cupboard door had been damaged from the installation of the lock mechanisms. It is recommended that the RP instructs a suitably qualified and competent contractor to repair the small breaches with a suitable compound capable of providing a minimum of 30 minutes fire resistance in order to maintain the integrity of the door.</p> | 2 | B |

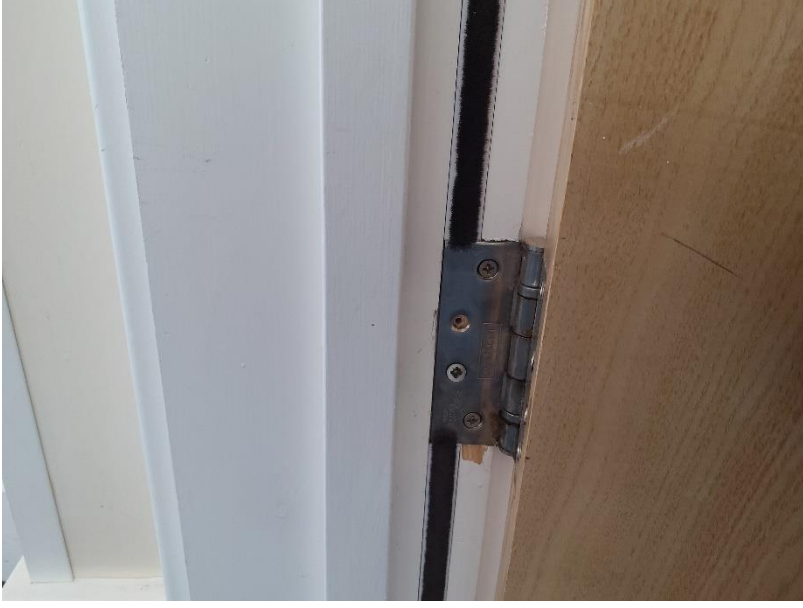
| 05 | <p>It was noted during this fire risk assessment that the lobby door on the second floor and the electrical riser door on the ground floor were both missing a screw on the bottom hinge. It is recommended that the RP instructs a suitably qualified and competent contractor to install a new screw which is in tandem with certification of the door set in order to maintain the integrity of the door.</p> | 3 | B |

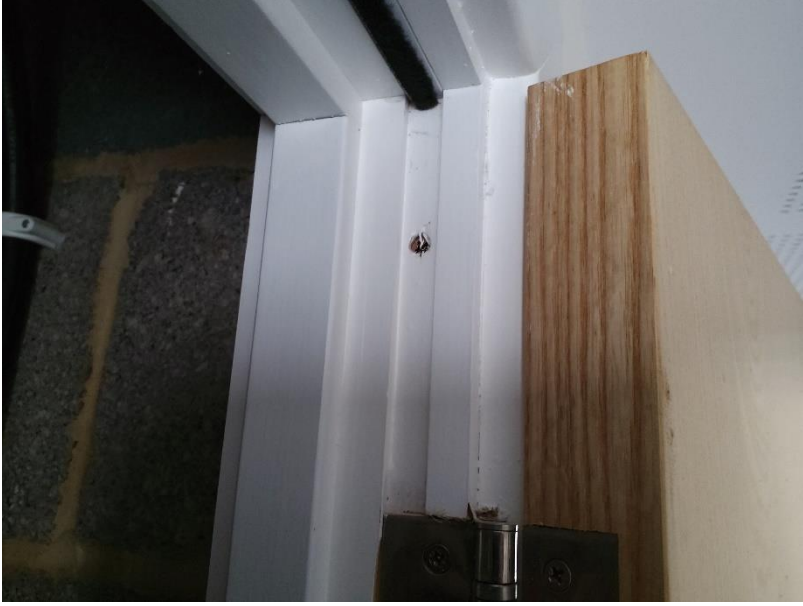
| 06 | <p>It was noted during this fire risk assessment that the smoke seal was missing at the top on the hinge side of the electrical riser door on the ground floor. It is recommended that the RP instructs a suitably qualified and competent contractor to replace this with a new cold smoke and intumescent seal to protect the means of escape from smoke and fire.</p> | 2 | B |

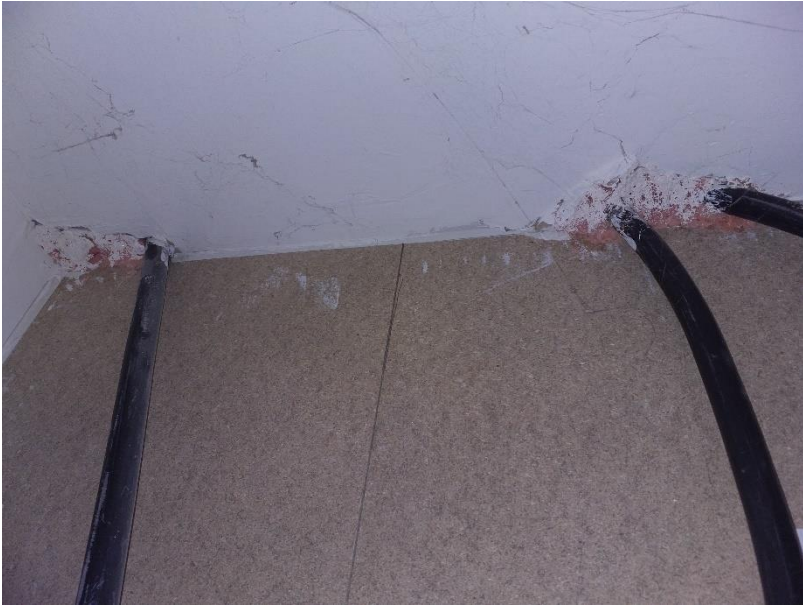
| 09 | <p>It was noted during this fire risk assessment that the second-floor risers had large breaches that had been filled with pink foam. Pink foam along with intumescent sealant is to be used as a fire-resistant sealant and or to fill small breaches. When used for large breaches this could cause the pink foam to fail before the presumed 30 minutes. It is therefore recommended that these large breaches be fire stopped with a substance which can provide a minimum of 30 minutes fire resistance to protect the means of escape from smoke and fire.</p> | 2 | B |

| It was noted during this fire risk assessment that the second-floor risers had large breaches that had been filled with pink foam. Pink foam along with intumescent sealant is to be used as a fire-resistant sealant and or to fill small breaches. When used for large breaches this could cause the pink foam to fail before the presumed 30 minutes. It is therefore recommended that these large breaches be fire stopped with a substance which can provide a minimum of 30 minutes fire resistance to protect the means of escape from smoke and fire. | | |

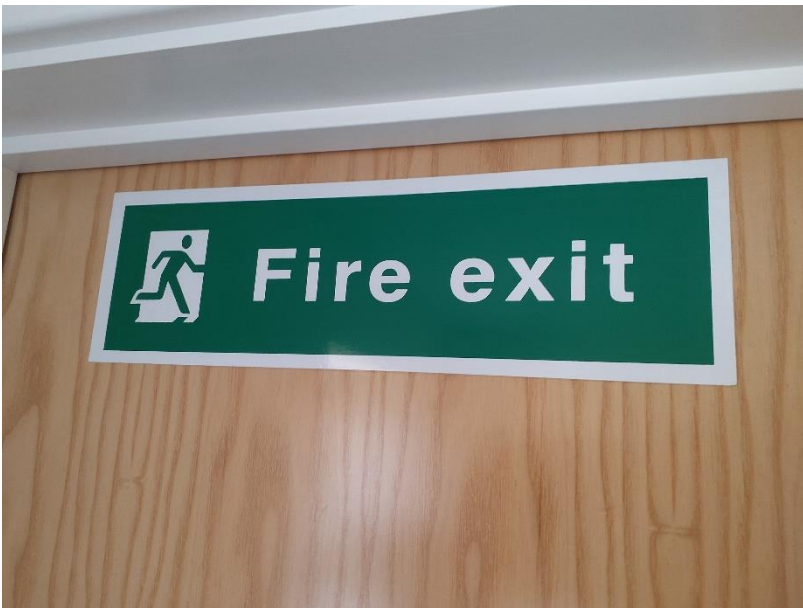
| 10 | <p>It is recommended that the client consider upgrading all signage to photo luminescent signage complete with 'FIRE EXIT' pictogram and directional signage in order to conform to safety signs and signals: the health and safety regulations 1996.</p> | 3 | B |

| A Fire action notice is installed by each exit door and is completed in full.<br><br>It is recommended that the client consider upgrading all signage to photo luminescent signage complete with 'FIRE EXIT' pictogram and directional signage in order to conform to safety signs and signals: the health and safety regulations 1996. | | |
