Combined Health, Safety and Fire Risk Assessment.

Reference Number:	FRA No. AGO/WELLMAN
Address of Premises:	16-32 Woolston Place Sherfield on Loddon Hook
Responsible person (e.g. employer) or person having control of the premises:	Wellman Property Management Ltd
Person (s) consulted:	Wendy
Assessor:	Josh Godfrey, TIFireE
Quality Control Auditor (If Required):	John Godfrey, GIFireE.
Date of assessment:	12 th July 2022
Date of previous assessment:	N/K
Suggested dates for review: (1)	July 2023

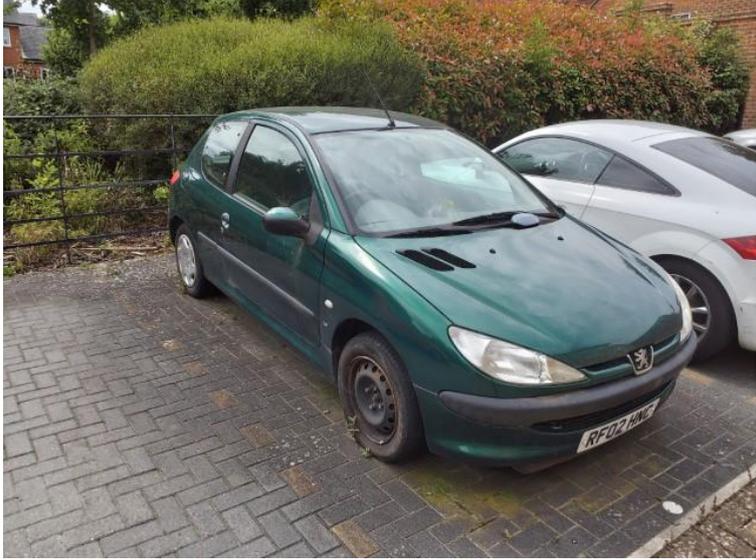
Action	Detail (to be read in conjunction with the report findings)	Priority	Action by whom	Date action undertaken
01	<p>According to the sticker attached to the consumer unit, the fixed electrical installation was last inspected and tested in 2018. All fixed electrical installations supplying the communal areas of a residential property should be inspected and tested by a competent person every five years in accordance with Electricity at Work Regulations / IEE Wiring Regulations Eighteenth Edition 2019 / British Standard 7671: 2018 and a written Electrical Condition Report (EICR) obtained.</p> <p>It is recommended that the RP create a management action to ensure the electrical installation is retested on a five yearly rolling basis.</p>	LOW	Client	
02	<p>It was noted during this assessment that there is abandoned car in the carpark. It is recommended that this car be removed as a priority as it creates a risk of arson.</p>

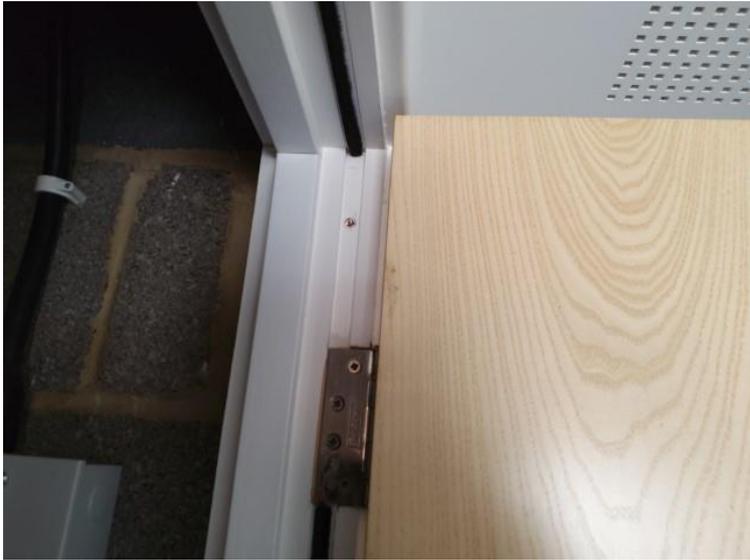
08	<p>It was noted during this assessment that the ground floor electric riser is missing a smoke seal. It is recommended that this seal be replaced as a priority in order to reduce the spread of smoke in a fire situation and provide adequate protection for the means of escape.</p>
